APPENDIX B. Ground photographs of San Juan and Animas rivers diversion structures.

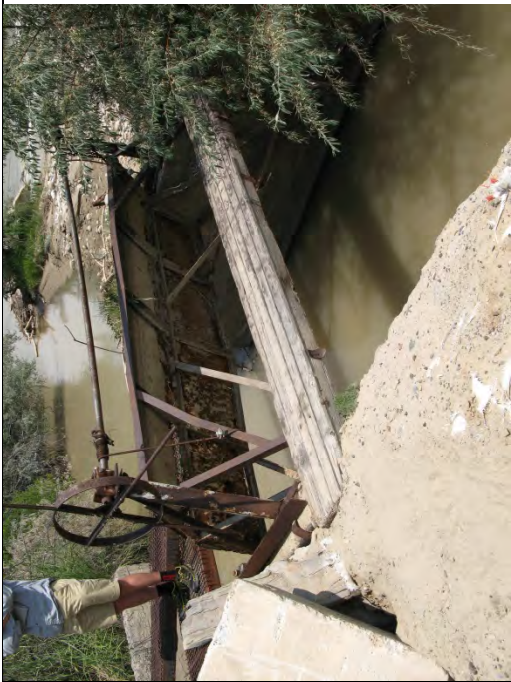
Non-functioning spillway gate at headgate

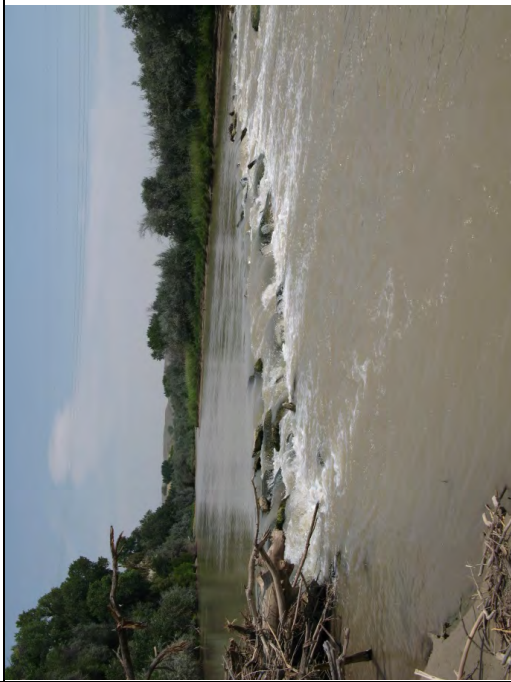
Head/grade control structure

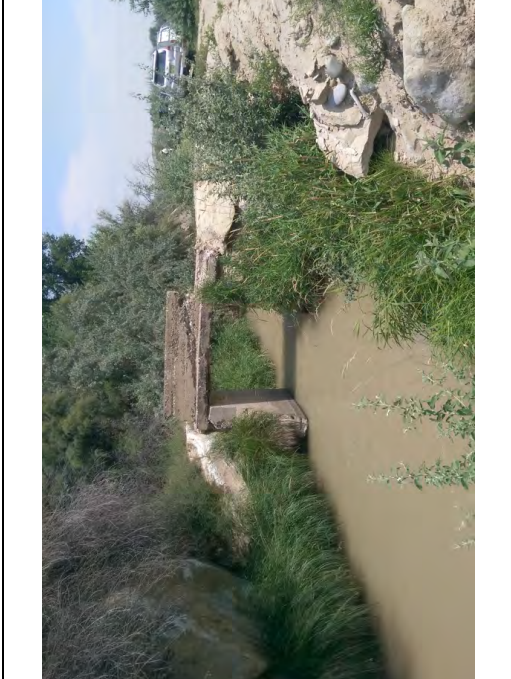
View upstream of old headgate structure

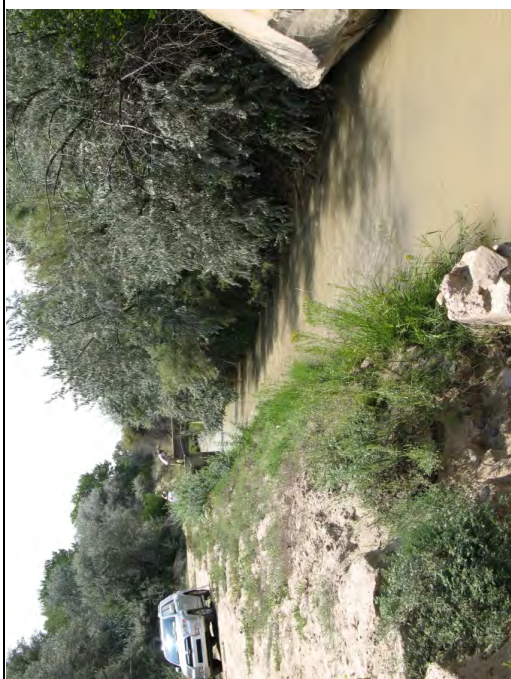
View downstream from current headgate of old headgate

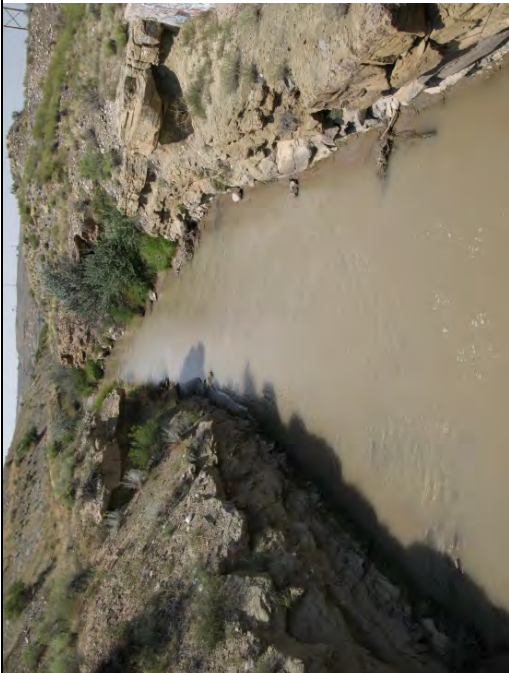
View downstream of headgate structure with gate operators removed.		Headgate structure.

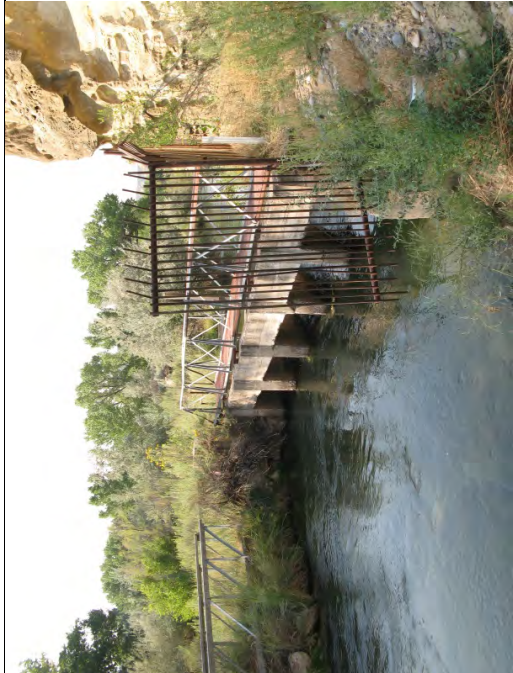
<p>Headgate structure, gates removed.</p>	  <p>View downstream of headgate structure.</p>

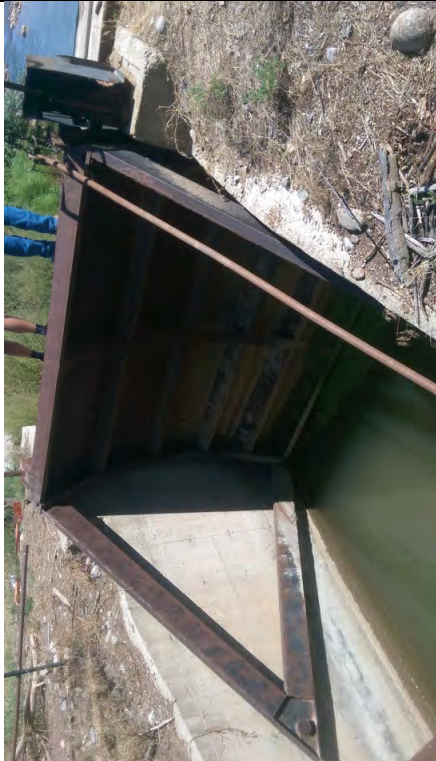
<p>Back of radial headgate.</p>	  <p>Secondary head/grade control structure, headgate at right.</p>
